Manhole Inspection Summary

Manhole # S41AA_052MH

Inspection ☐ Is Incomplete Rating: **5) Immediate Attention Required**

Location Address: **1234 e madison st**

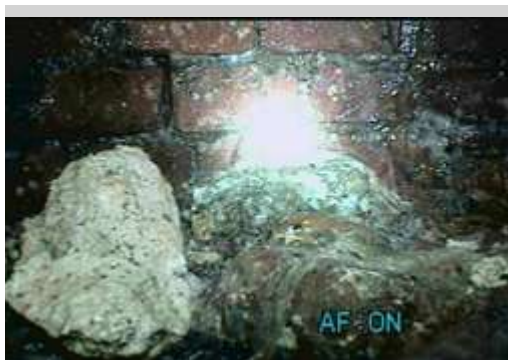
Defect 5

Condition: ☐ Sound ☐ Cracked ☐ Root Intrusion ☐ Deteriorated ☐ Leaks ☒ **Debris**

bench debris

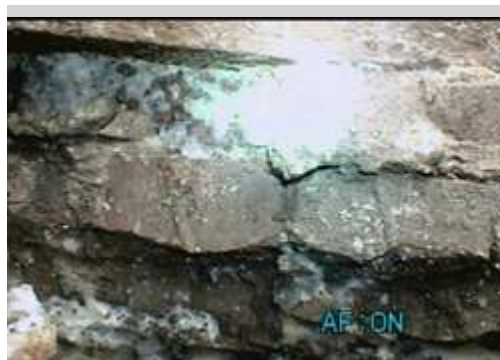
Defect 4

Condition: ☐ Sound ☐ Cracked ☐ Root Intrusion ☒ **Loose Brick** ☒ **Deteriorated**

chimney cond loose bricks, chimney cond deteriorated

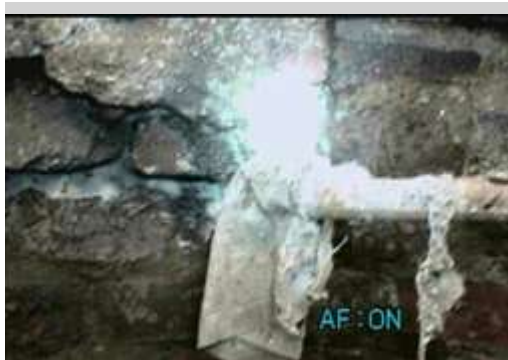
Defect 3

☒ **Evidence Of Surcharge** Depth: **9.9** (ft.) ☐ Active Surcharge Present

evidence of surcharge

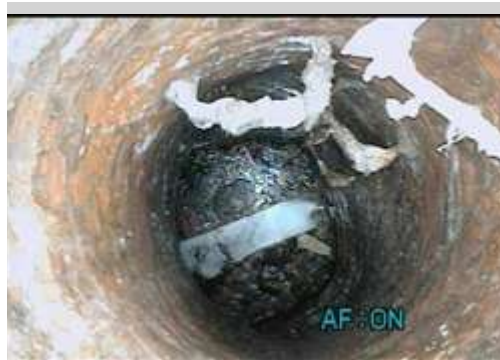
Defect 2

Count: **6** Missing: **0** ☒ **Corroded**

steps

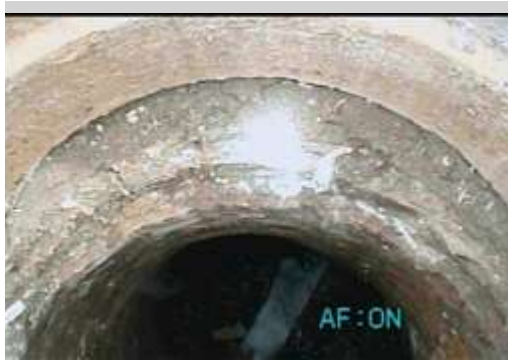
Defect 1

Offset: **5.5** (in.)

offset

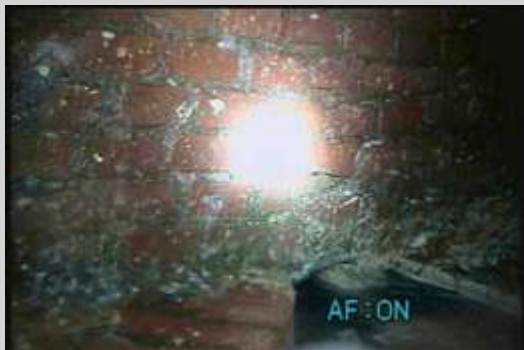
12 O'Clock Outflow

under shelf

Deposits: ☐ None ☐ Mud ☒ Gravy ☒ Debris ☐ Grease

Silt Depth: 7 (in.) Deposits Extent: **Heavy**

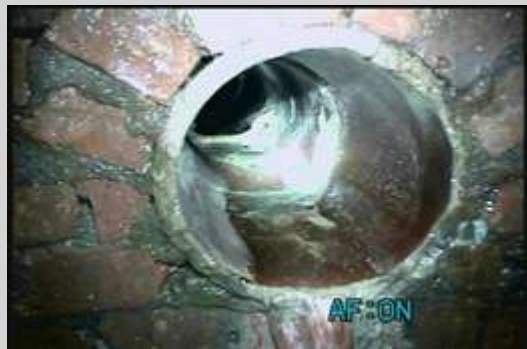
9 O'Clock Inflow

Deposits: ☐ None ☐ Mud ☒ **Sludge** ☒ **Debris** ☐ Grease

Silt Depth: 8 (in.) Deposits Extent: **Heavy**
